# Manhole Inspection Summary

Manhole # S07SS1016MH

Insp Date: **11/14/08 9:12 AM**

**Location** Address: **WINNER AVE**

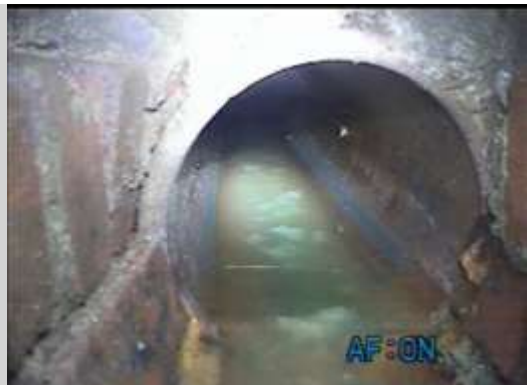
3 O'Clock Inflow

Invert Depth: **11.34** (ft.) Flow Characteristics: **Slow**

Infiltration: **None** Pipe Seal Cond: **Sound**

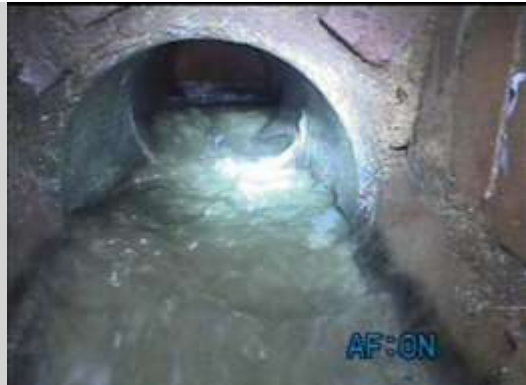
6 O'Clock Inflow

Infiltration: **None** Pipe Seal Cond: **Sound**
